Geotechnical and Constructability Lessons from the WALK Bridge Program

Richard J. Leso, P.E.
Connecticut Department of Transportation
District 5 - Construction

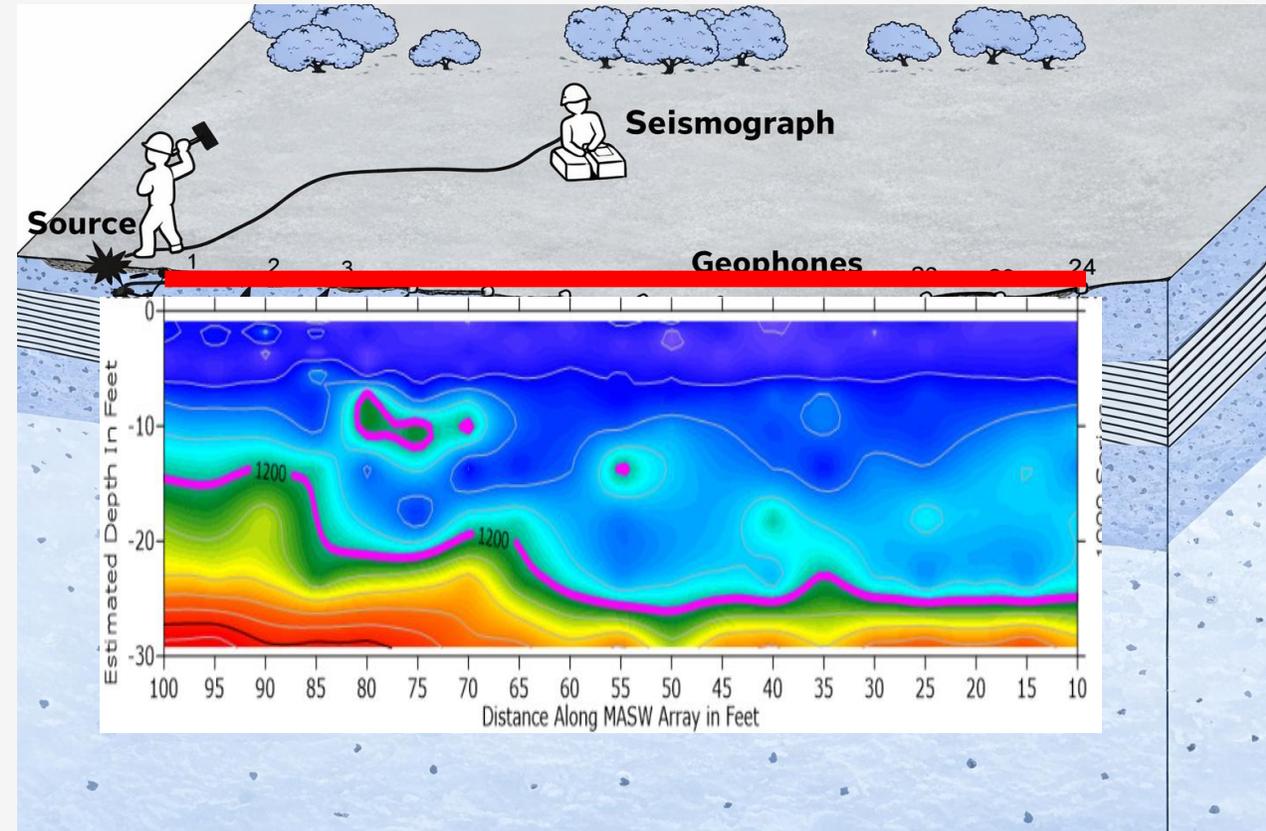
Seismic Source Testing

- Multichannel Analysis of Surface Waves (“MASW”)
- Provides a detailed section showing surface wave velocities
- Surface wave velocities are used to infer soils’ relative stiffness/density

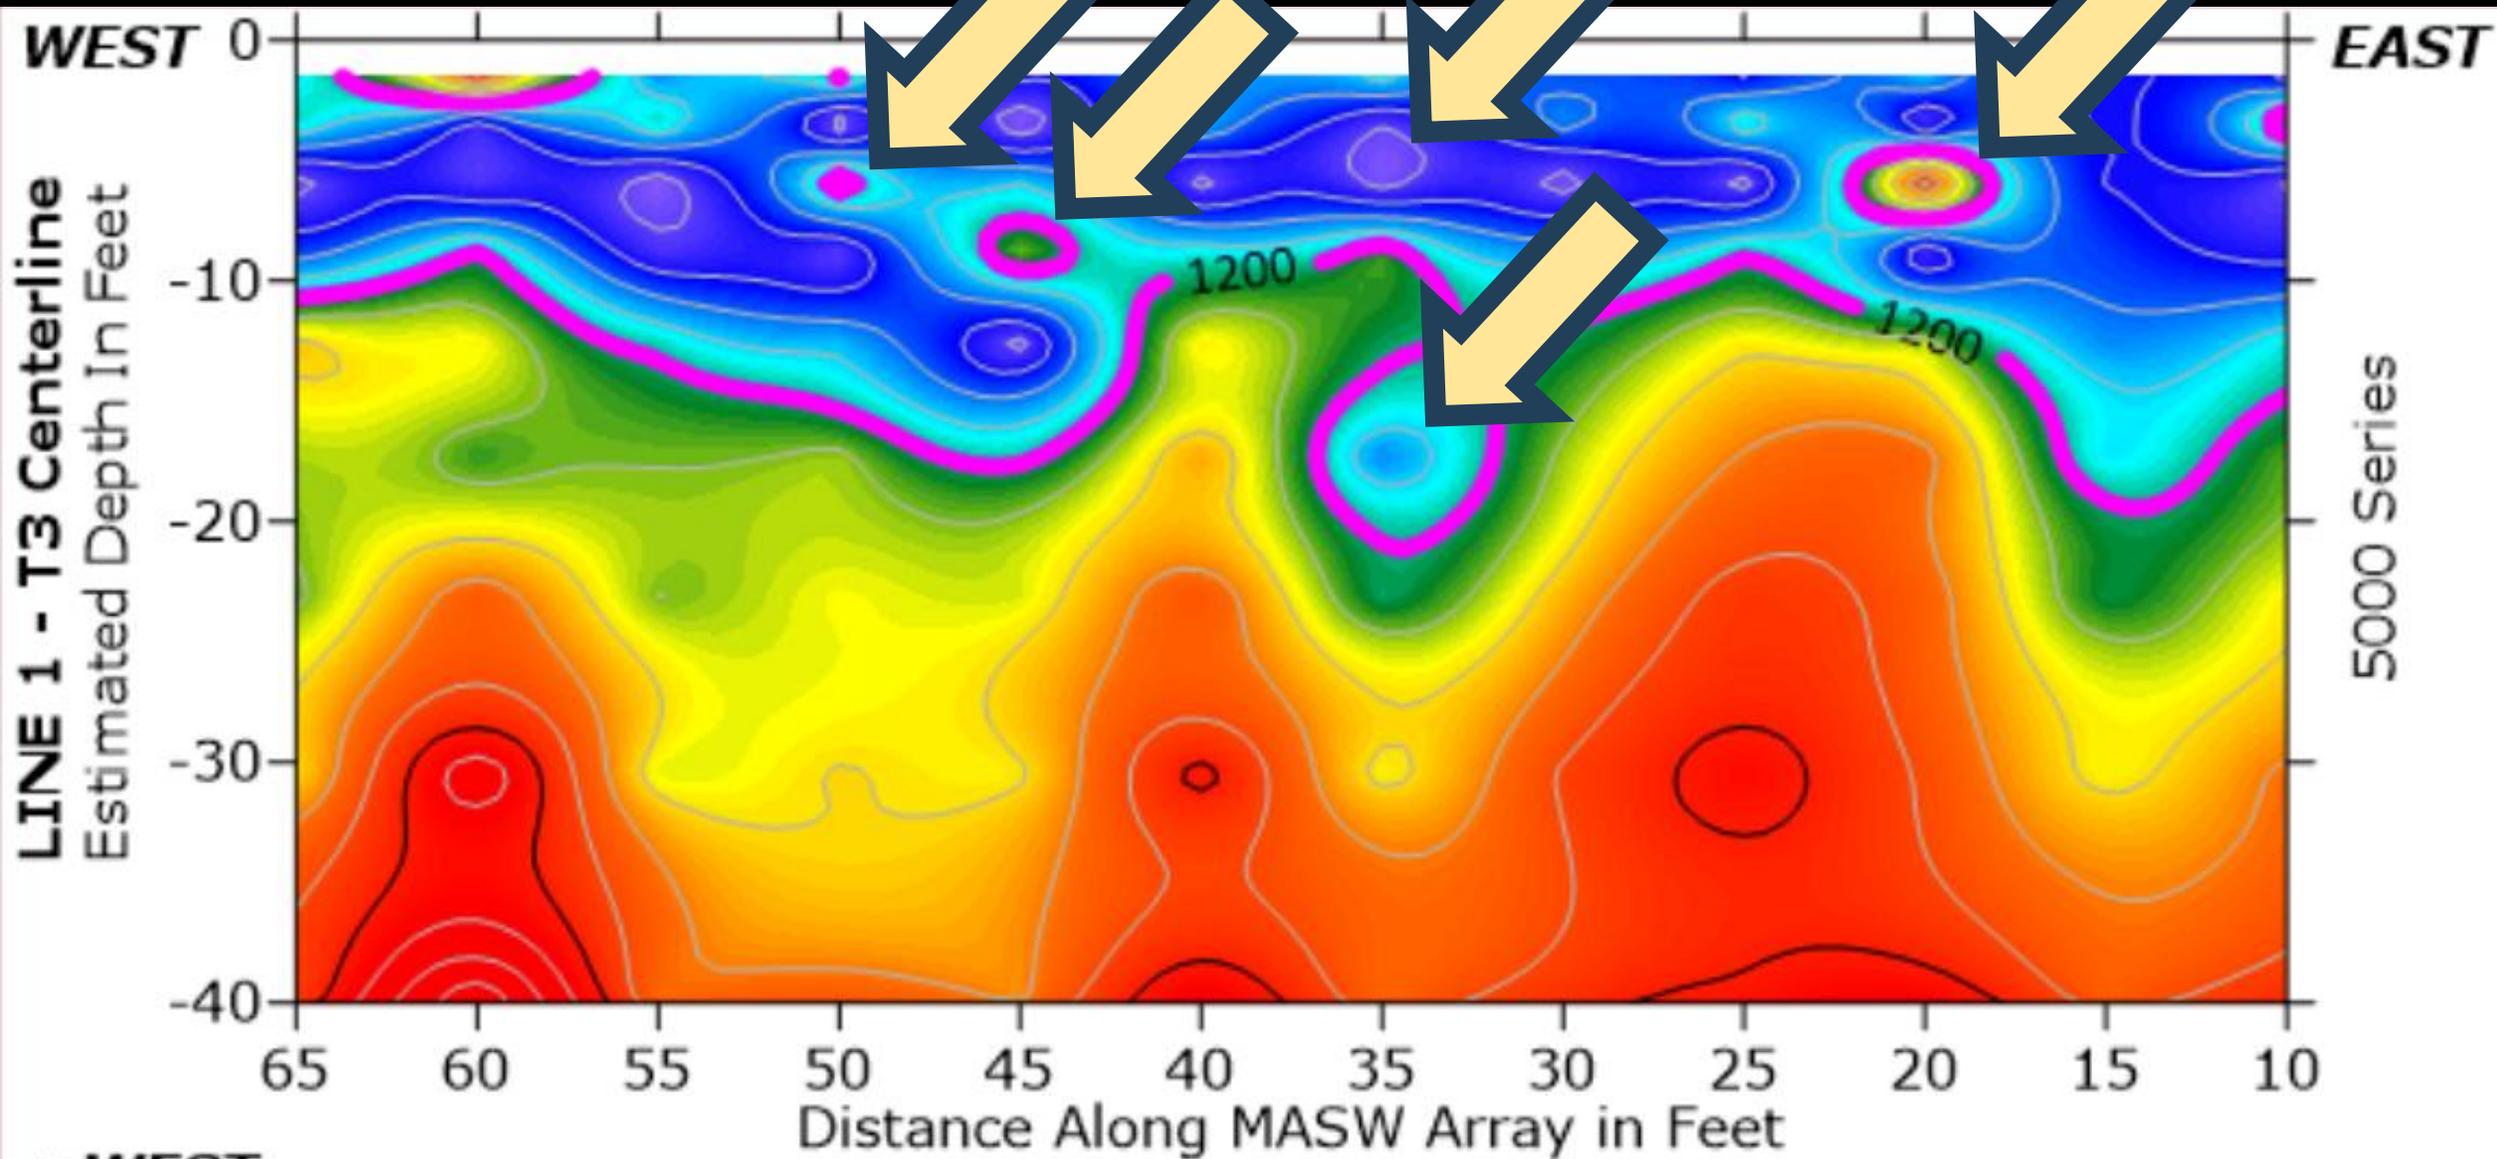
Cool Colors = Less Dense
Warm Colors = More Dense

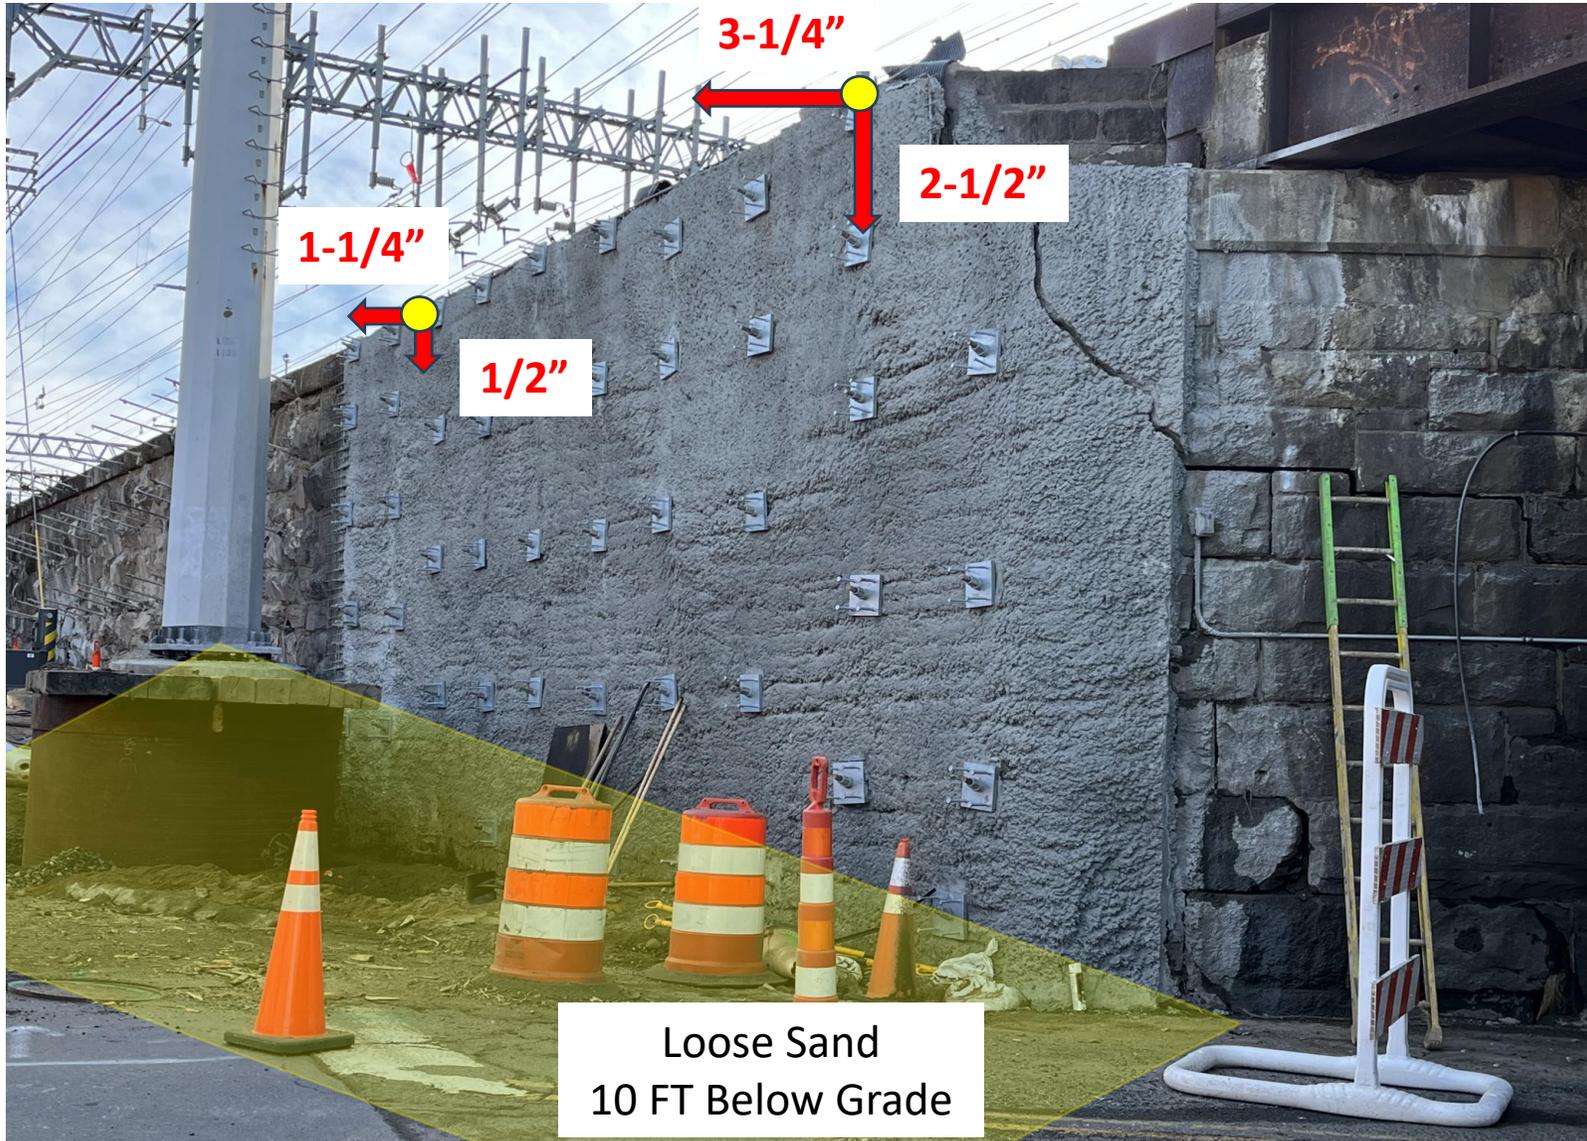
Cause & Effects

Consolidation & Migration of Existing Loose Sand Layer

Displacement of Retaining Wall

Embankment Migration & Localized Shear Failures

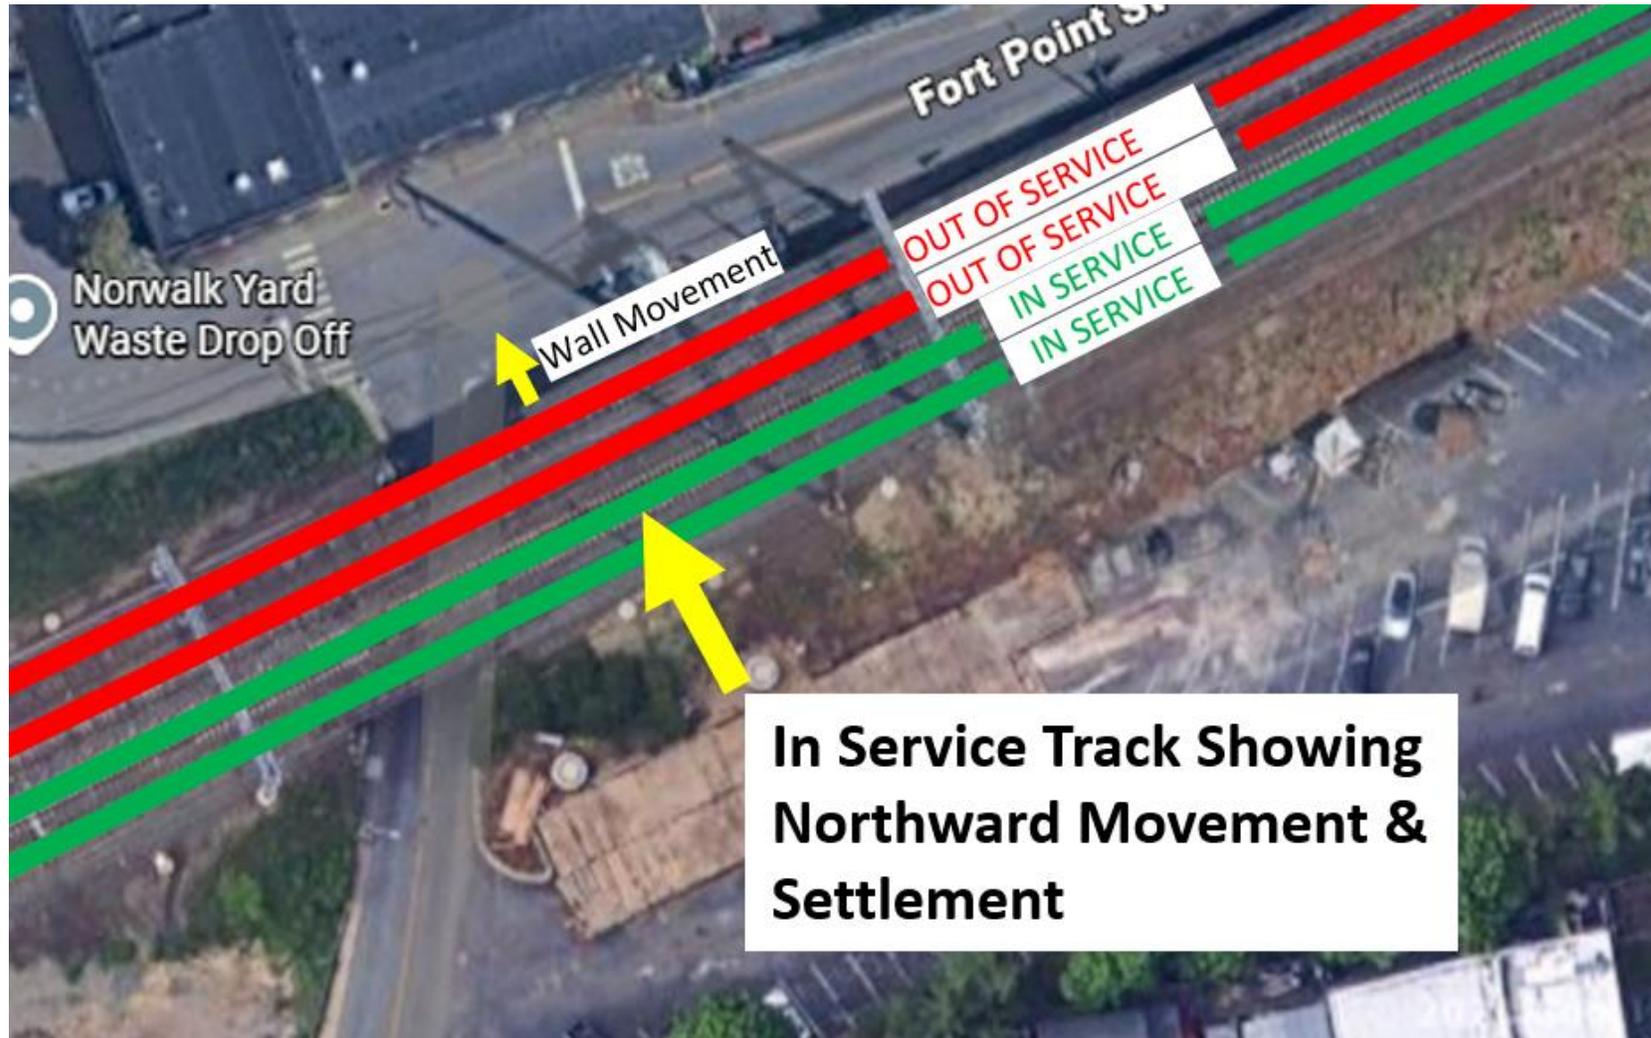
Cause & Effects

Embankment Migration & Localized Shear Failures

Track Creep

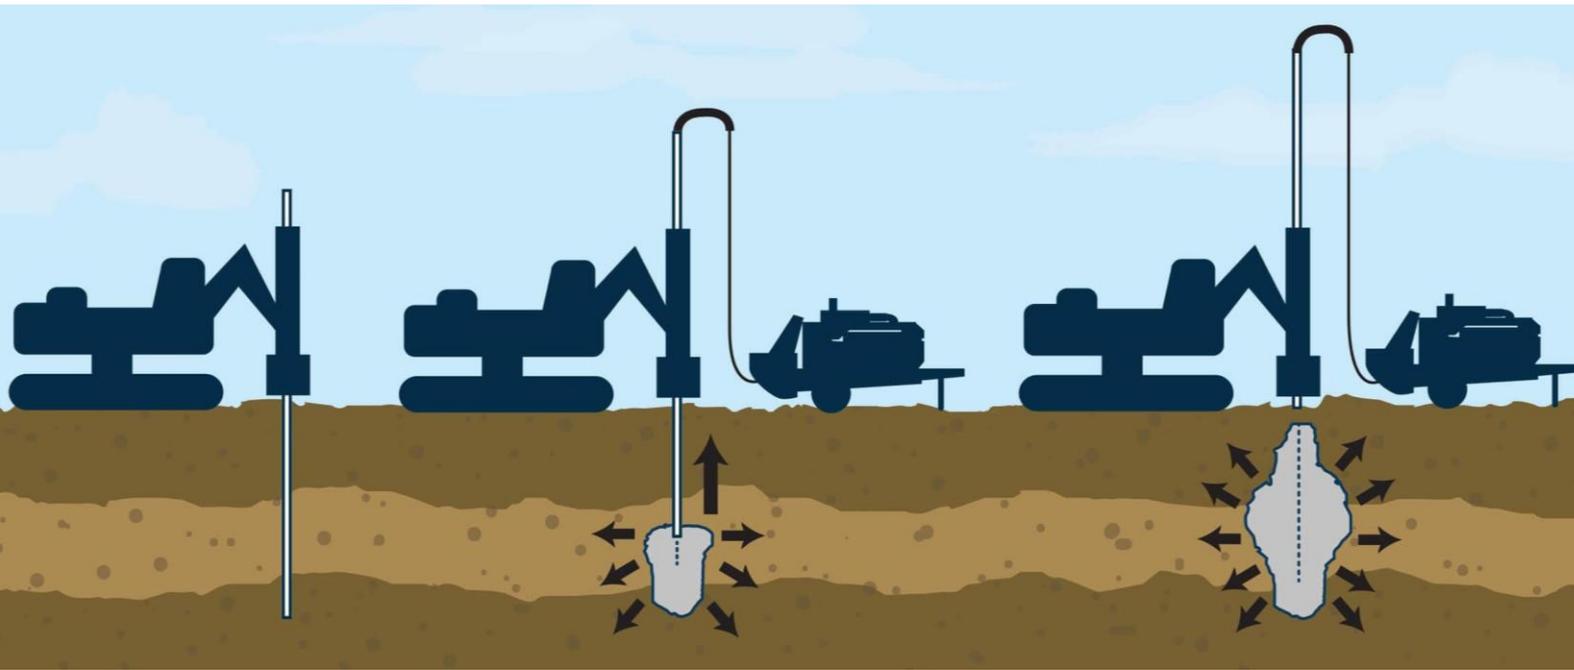
Solution: Permeation Grouting

- **Stiffens soils by filling voids with low viscosity grout**
- **Transforms granular soils into sandstone-like mass**
- **Cost: \$6M (Extra Work)**
- **Duration 4-6 Months**

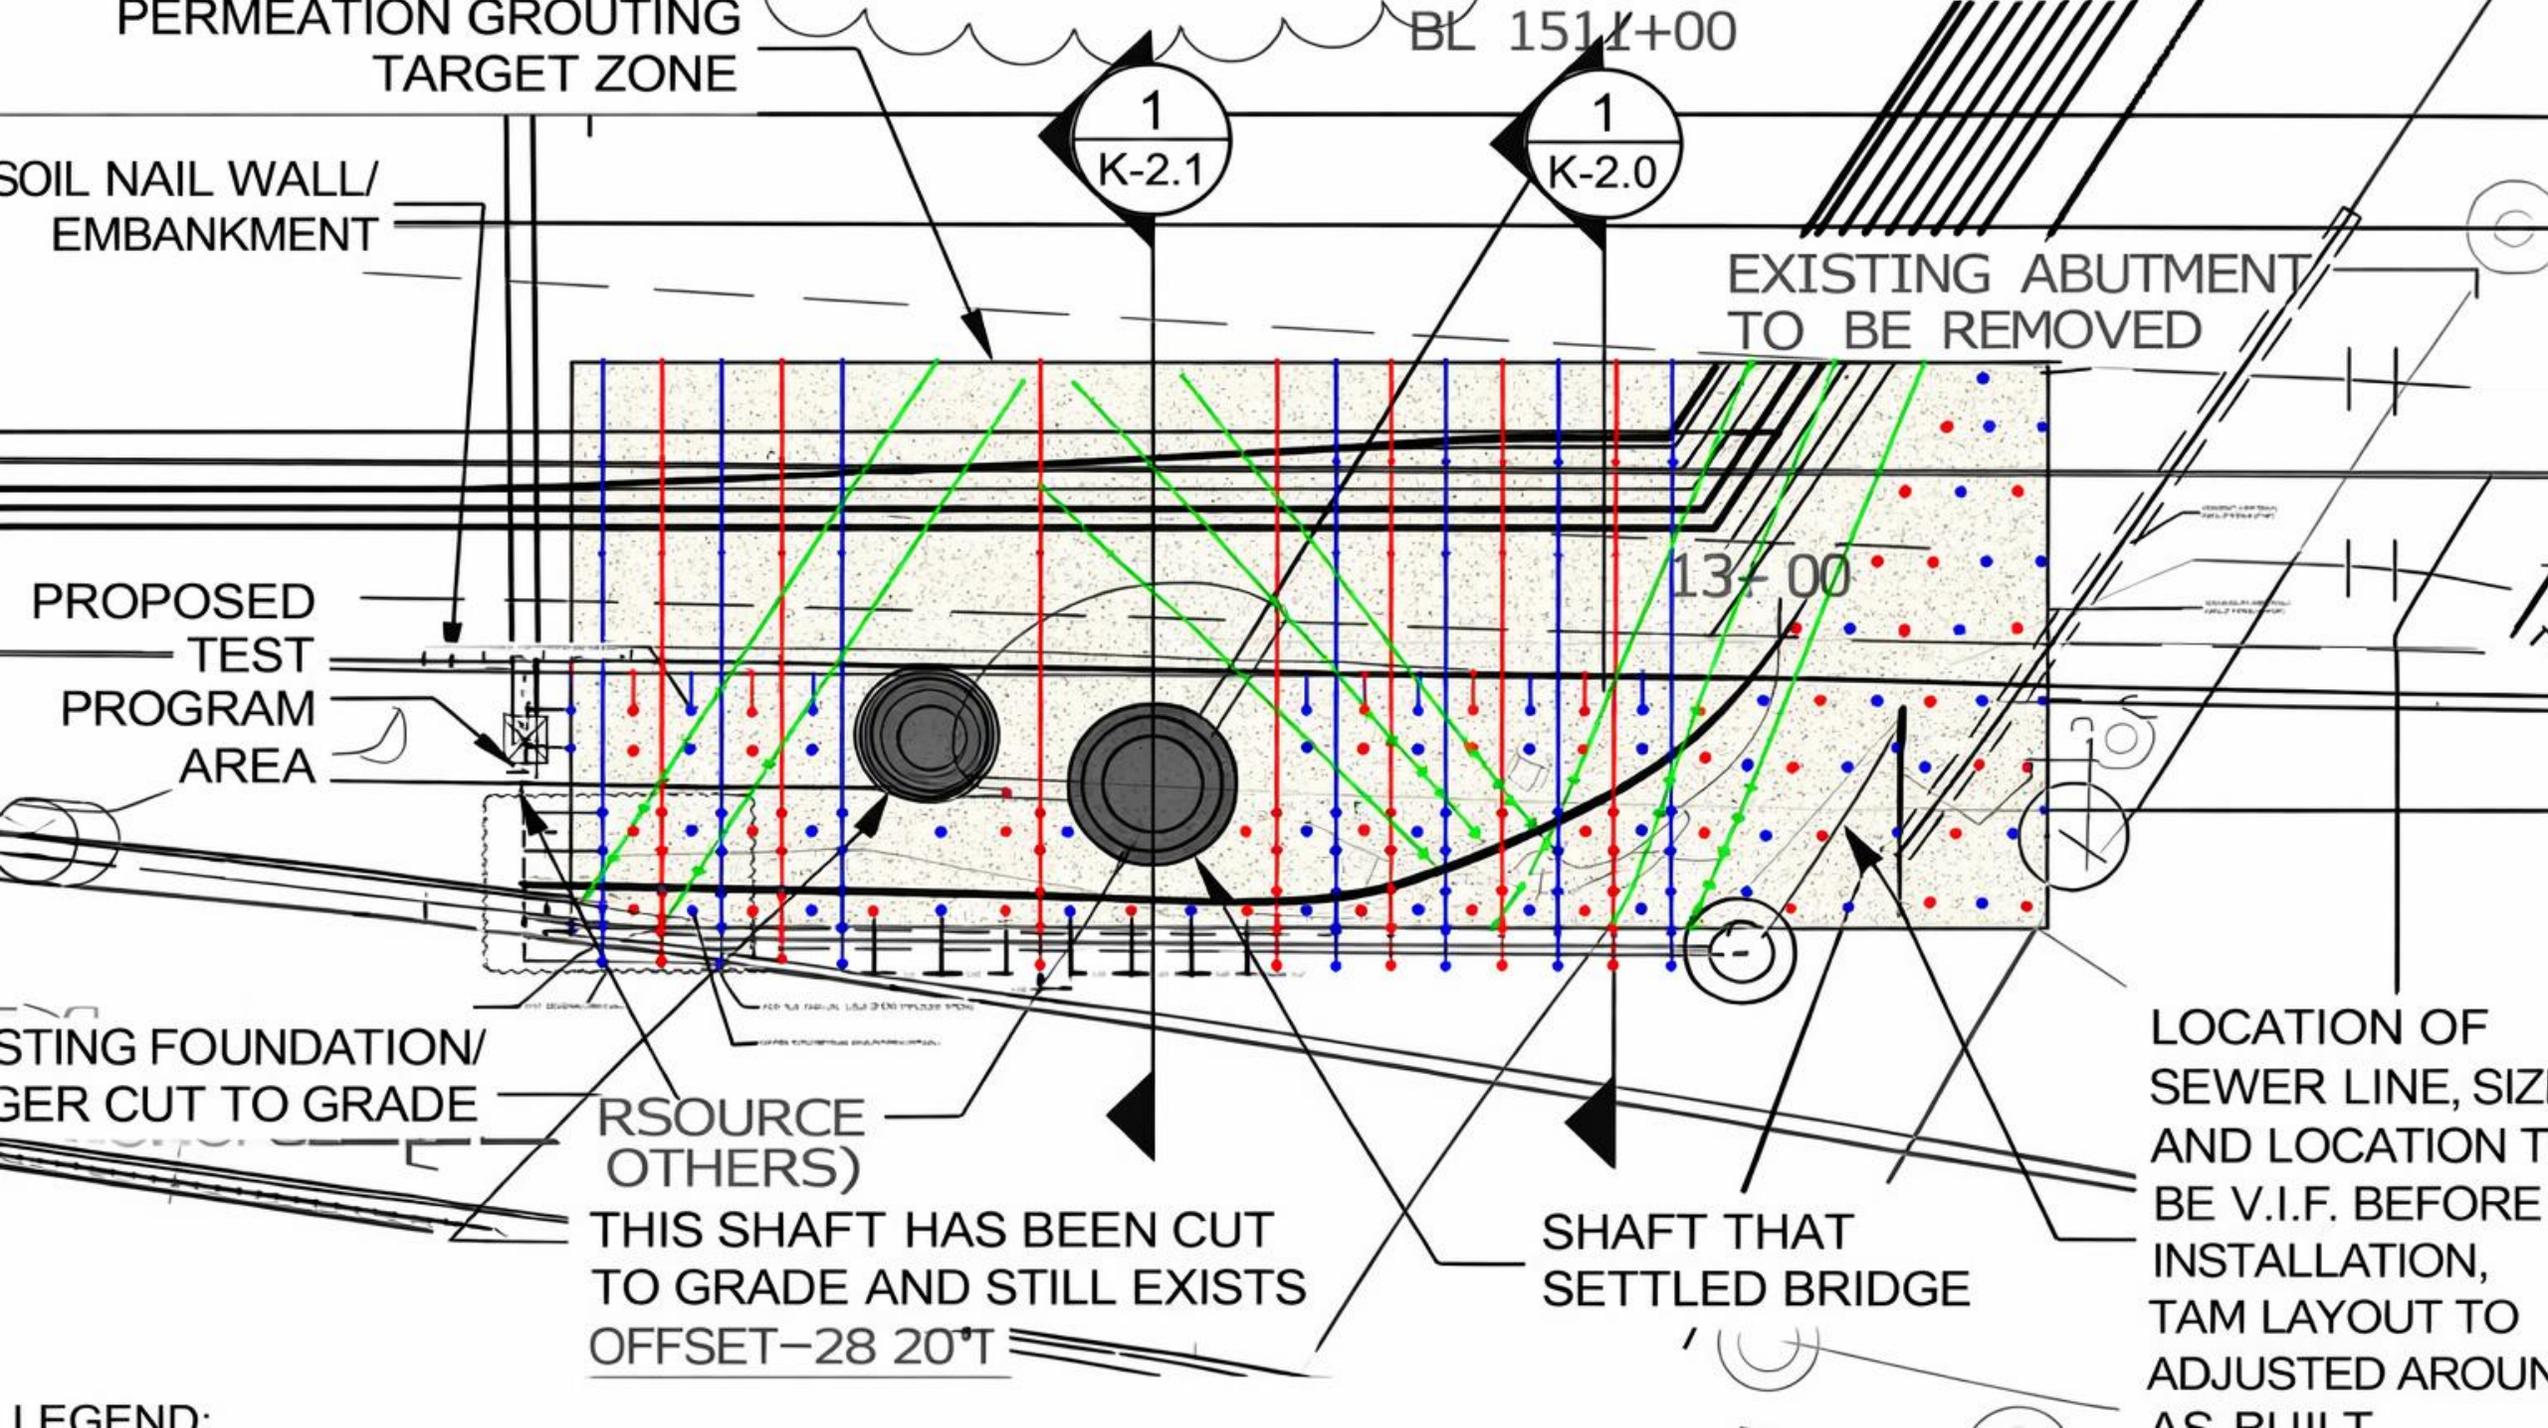
PERMEATION GROUTING TARGET ZONE

SHAFT THAT
SETTLED BRIDGE

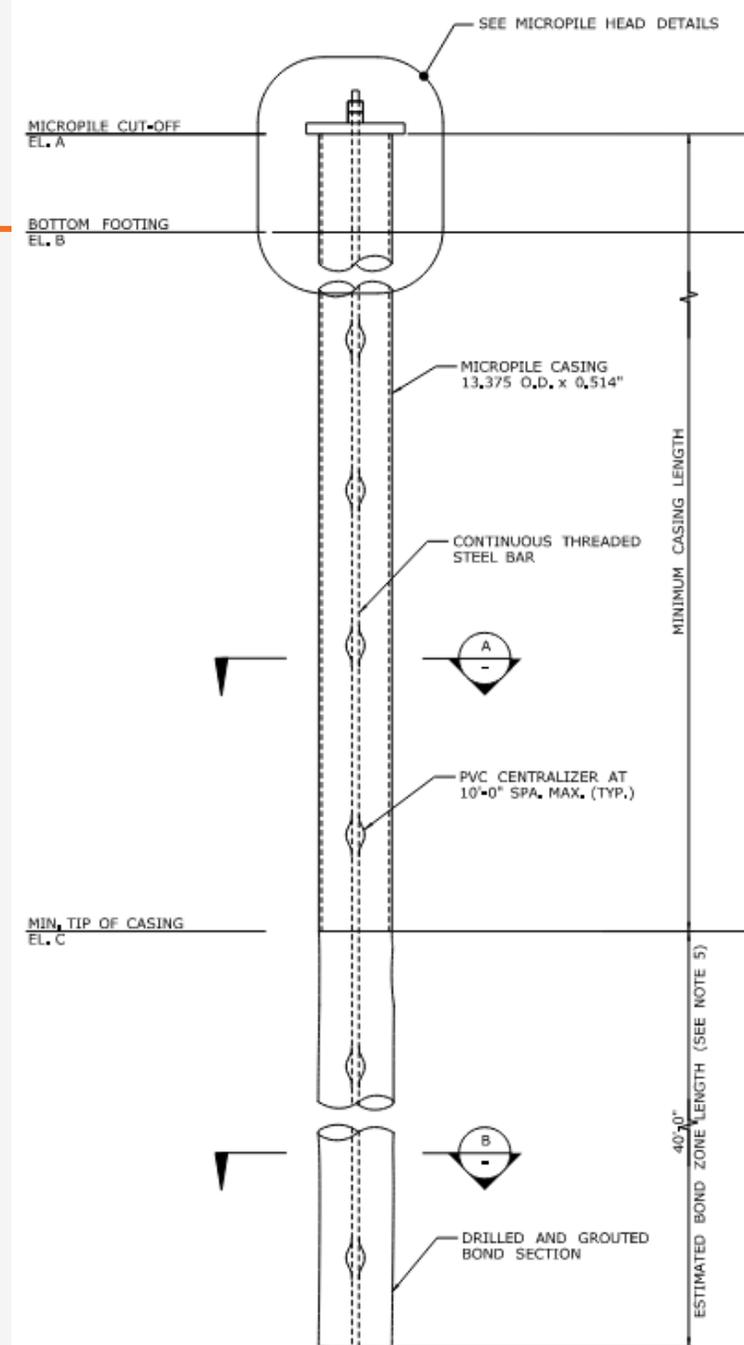
VERTICAL MICROPILE ELEVATION

Permanent Micropile Installation

- **Fines migration and material blowback during drilling**
- **Persistent accumulation of material at bottom of casing**
- **Ground loss & surface subsidence**
- **Excessive grout overruns**
 - **Up to 330% of theoretical volume irrespective of drilling method**
- Irretrievable casing at many pile locations
- Measurable displacement of adjacent structures

- Potential Modifications to Micropile Design
 - Cost-Schedule-Risk evaluation underway
 - Alternative designs based on Phase 2C constructability finding
- Enhancing next phase SOE to better tolerate the observed differential settlement and ground loss

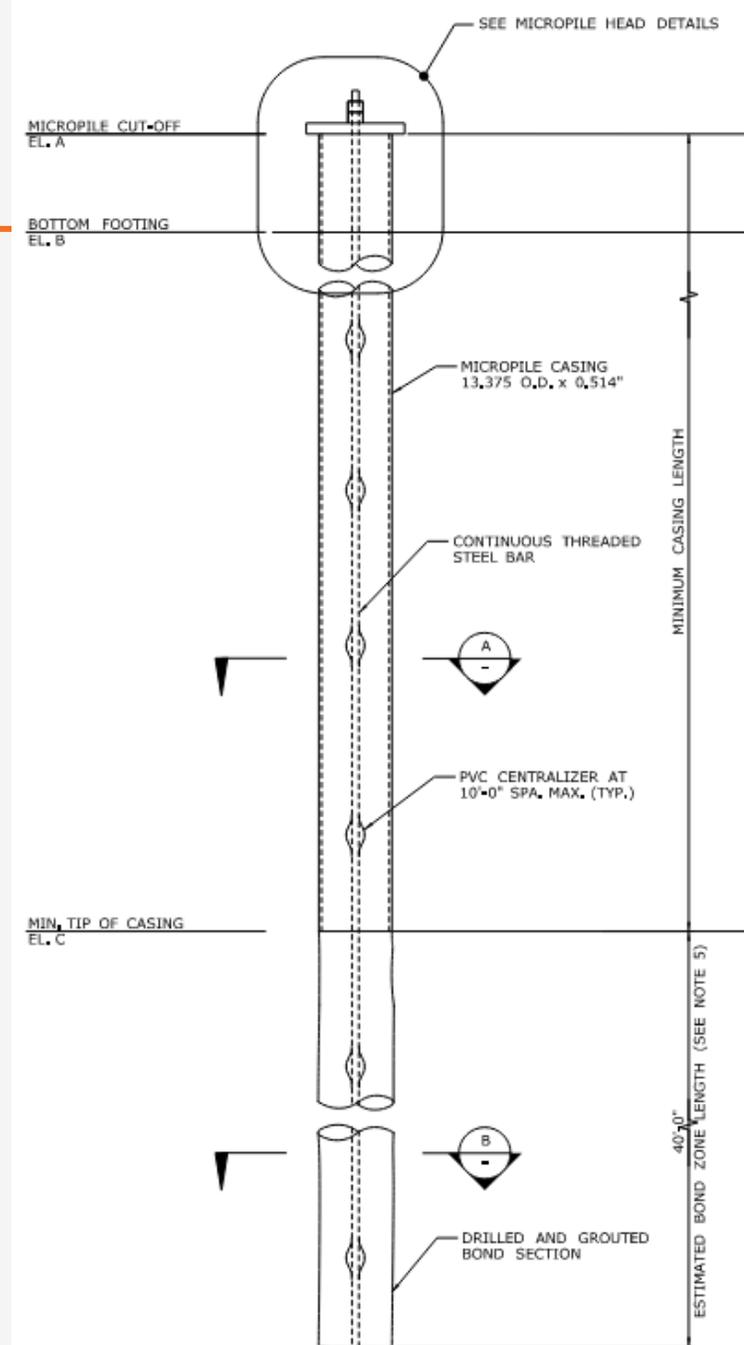
VERTICAL MICROPILE ELEVATION

- Fines migration and material blowback during drilling
- Persistent accumulation of material at bottom of casing
- Ground loss & surface subsidence
- Excessive grout overruns
 - Up to 330% of theoretical volume irrespective of drilling method
- **Irretrievable casing at many pile locations**
- Measurable displacement of adjacent structures

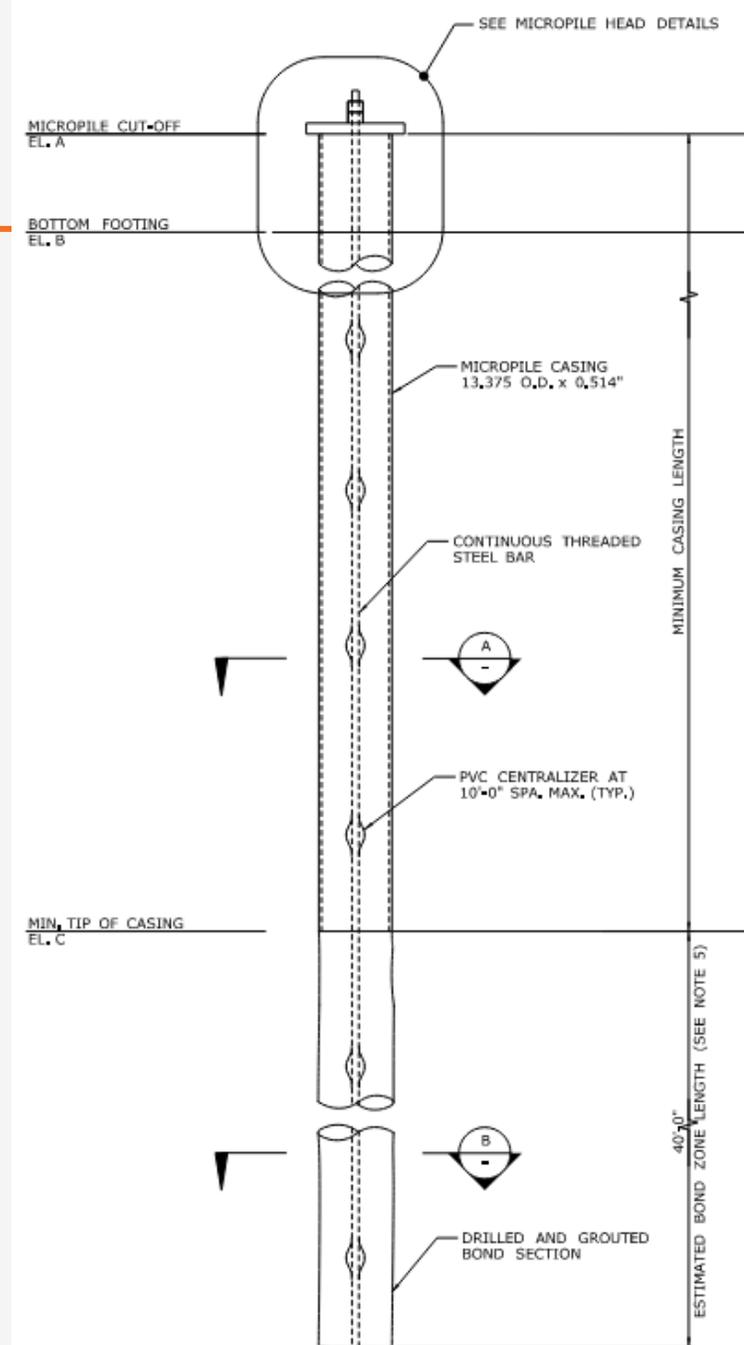
VERTICAL MICROPILE ELEVATION

- Fines migration and material blowback during drilling
- Persistent accumulation of material at bottom of casing
- Ground loss & surface subsidence
- Excessive grout overruns
 - Up to 330% of theoretical volume irrespective of drilling method
- Irretrievable casing at many pile locations
- **Measurable displacement of adjacent structures**

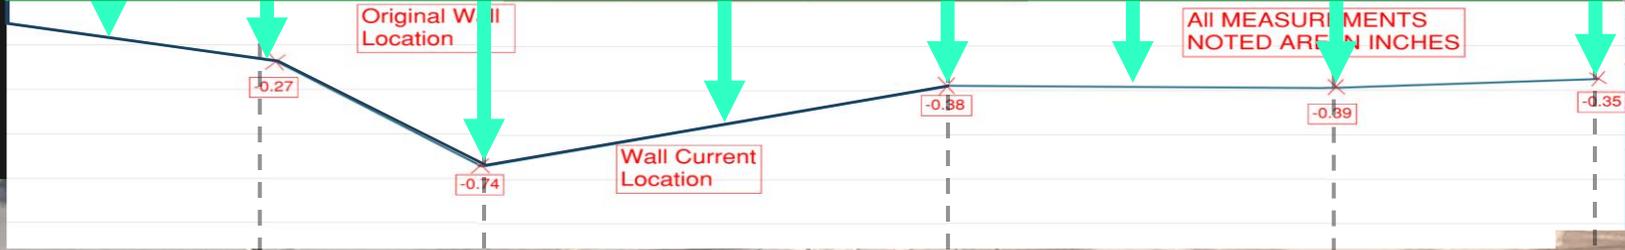
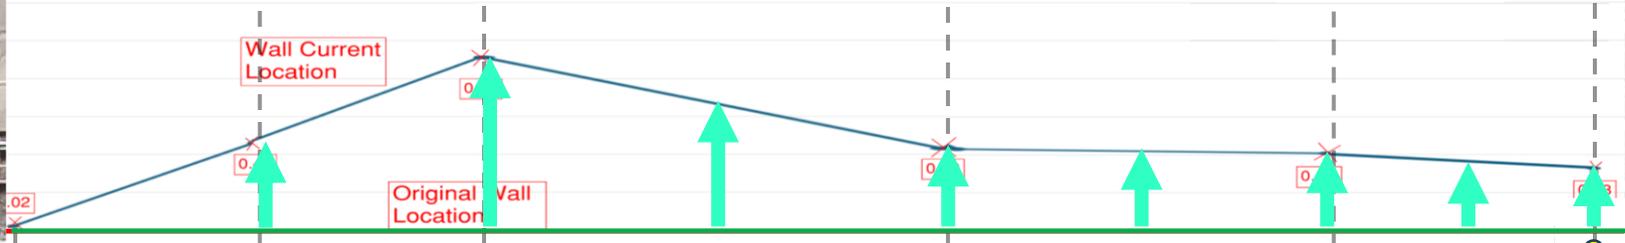
Plan View (Lateral Mvmt, Toward Excavation)

Elevation View (Settlement)
