The US 50 – Blue Mesa Bridge Emergency Repair**Douglas Whittaker, PE, SE of Michael Baker International**

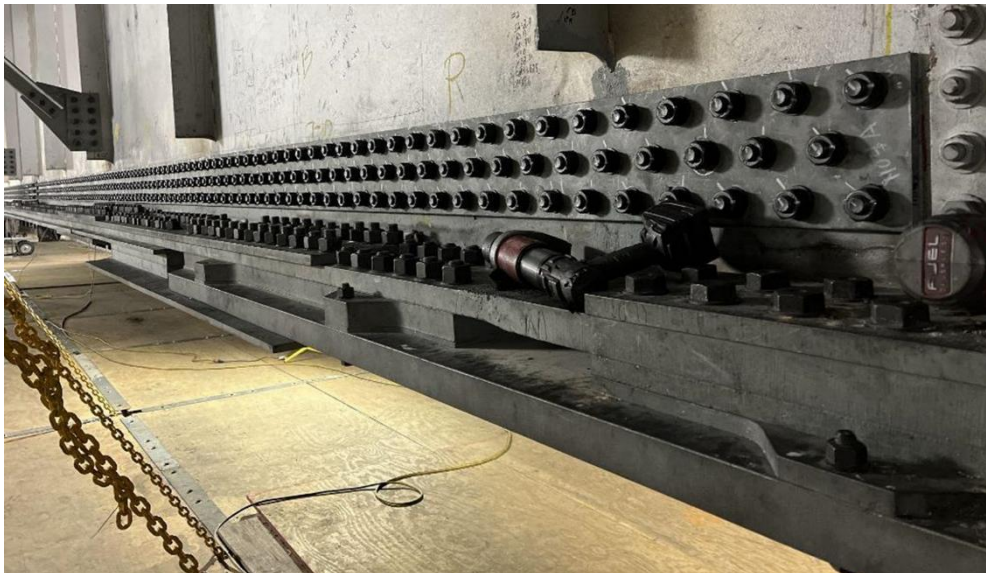
In April 2024, while conducting the Federal Highway Administration (FHWA) required non-destructive evaluation of Non-Redundant Steel Tension Member (NSTM) bridges, the Colorado Department of Transportation (CDOT) discovered two partial fractures in the bottom tension flanges of the US-50 Blue Mesa Reservoir Bridge near Gunnison, Colorado. The bridge was immediately closed, and Michael Baker International helped to develop safe loading limits to get inspection equipment back on the bridge. The closure of the bridge to public traffic, however, resulted in a six-hour detour for local motorists. Emergency repair work using the Construction Manager / General Contractor (CMGC) method of contracting with Michael Baker International as the designer and Kiewit Infrastructure Co. as the contractor was undertaken immediately to identify and implement solutions to repair this critical bridge, as well as a second crossing of the reservoir of nearly identical construction.

Thorough non-destructive testing began and ultimately revealed numerous indications throughout many of the structure's 118 tension flange butt welds. Widespread transverse cracking of the girders' web-to-flange welds was also discovered. These defects led to the eventual decision to implement global plating of the bottom tension flanges to provide an alternate load path if any of the defects were to result in a total fracture of the flange. A novel approach to deter the propagation of cracking through the web was also implemented, acting in conjunction with the flange plating to provide a fully redundant system. Repair plates consisted of A514 (100 ksi) material to limit weight added to the bridge during the repair. Critical repairs were completed by July 3, 2024, to allow limited traffic back on the bridge. Additional repairs and full global plating were completed on both bridges by November 15, 2024.

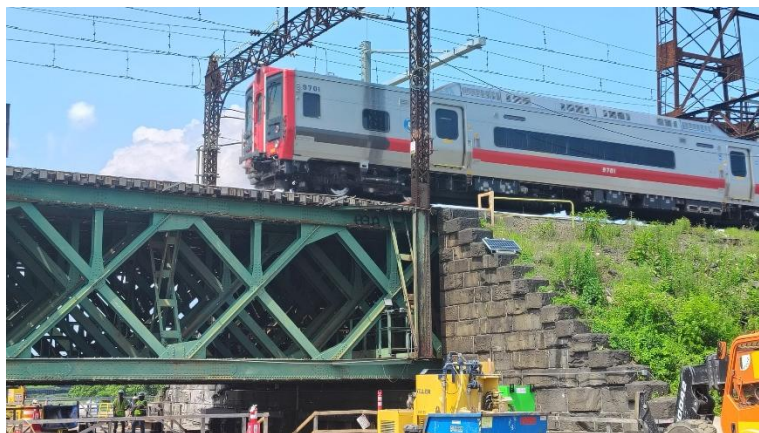
The new WALK Bridge, currently under construction, will be a vertical lift bridge with dual 240-foot spans and 150-foot towers supported by 12-foot diameter drilled shafts. Designed for resilience, redundancy, and minimal maintenance, it will significantly improve navigational clearance and operational reliability. The project also includes upgrades to nearby interlockings, catenary systems, and adjacent bridges, forming a comprehensive corridor modernization effort.

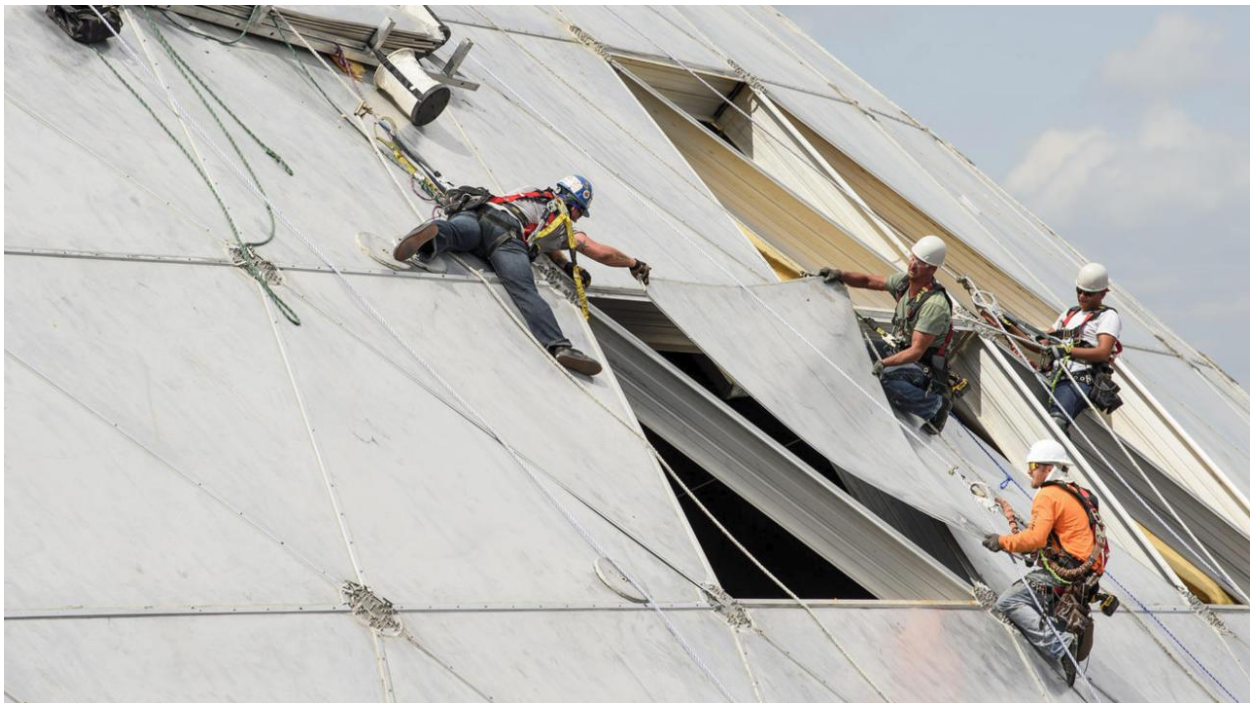
Built in the late 1980s, the Gampel Pavilion is an icon of the University of Connecticut (UConn) campus and its legendary basketball program. The one-of-a-kind geodesic dome roof, supported on a reinforced concrete plinth, acts as the building enclosure, structure, and interior ceiling of the Pavilion. Housed within the building are the basketball court, seating bowl, and ancillary service areas. After decades of use, UConn decided to rehabilitate all 2,016 frayed and deteriorated ceiling tiles and undertook an expedited project that needed to be complete in the very short period between commencement and the start of basketball season. The Pavilion's height and size, unique ceiling system, proprietary "spring-supported" court floor, and seating bowl, made rehabilitating the ceiling tiles and catwalks extremely challenging. The project team developed an innovative repair method that allowed the contractor to nearly simultaneously re-seal the roof, replace the ceiling covering, and repair the catwalk.

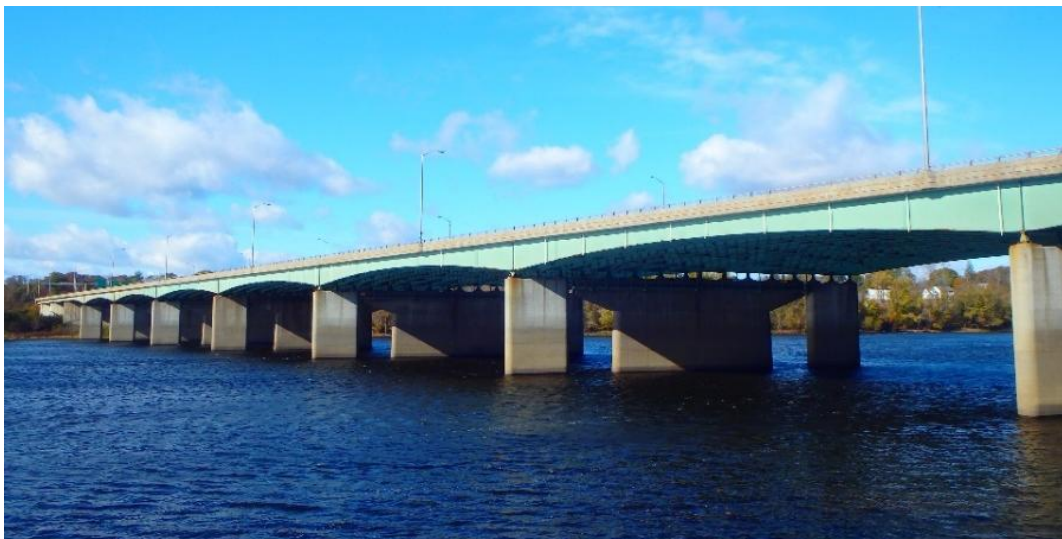
The Dexter Coffin Bridge in central Connecticut is a 12-span steel structure carrying four lanes of traffic in each direction. It was originally constructed in 1956 and subsequently widened in 1985. The original structure consisted of 10 riveted plate girders, and a widening addition in the eighties added 6 welded plate girders. The superstructure had a condition rating of 5 (fair) with a load rating less than 1.0. Areas identified that required rehabilitation and strengthening with use of UHPC included advanced pack rust between bottom flange plates; flange local buckling; and negative moment regions.

The rehabilitation of the Dexter Coffin Bridge (completed summer of 2025) is an excellent case study of the practical and real-world applicability of using UHPC in a bridge rehabilitation project and the first use case in CT. This presentation will discuss the innovative rehabilitation techniques used on the Dexter Coffin Bridge, including the use of UHPC to encase the bottom flange to address flange local buckling, negative moment strengthening, and pack rust. The purpose of using UHPC in this rehabilitation effort is twofold. First, the strength of the UHPC will allow the regions of the structure requiring rehabilitation and strengthening, increasing the rating factor as is required as part of the project. Second, the superior durability of UHPC encapsulating the steel will prevent the ingress of water and chlorides to the underlying steel, preventing further section loss. The rehabilitation of this bridge is intended to extend the service life of the structure and increase the load rating capacity.
